**Flood Control Project Maintenance
Levee Inspections**
LMA District Cover Sheet
Spring 2017 Levee Inspection Results

Sacramento Maintenance Yard Willow Slough Bypass

Spring 2017 Levee Inspection Results

Waterway			Bank	Unit Miles
Unit No. 01 Willow Slough Bypass or North Levee			Left	5.05
	Spring (March - May)	Summer (June - August)	(September - November) Fall	Winter (December - February)
Unit Maintenance Rating (Fall Only)				
Date of Inspection	4/18/2017 - 4/18/2017			
DWR Inspector	Zach Jojola			
Accompanied By	Casey Lund

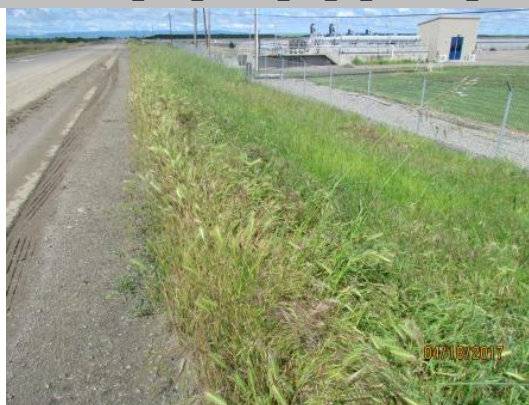
Photo 1 of 1 : SP_2017_ST0012_295_19_20170419_00018.jpg

Tall grass on landside levee slope, blocking visibility. Spring 2017.

LM Start	0.56	Rating **	U	Issue No.	20
LM End	3.51	Issue Type +	Ma	Location *	WS
Category	Earthen Levee			GPS Latitude/Longitude	
				Start	End
Item	Vegetation			38.590585 °	38.590767 °
				-121.675592 °	-121.730035 °
DWR ID	DWR_ST0012_01_s _ 2017_20				
Comment Code					
V1 : Control annual grass and weeds on the levee slopes and easements.					
Inspector Comment

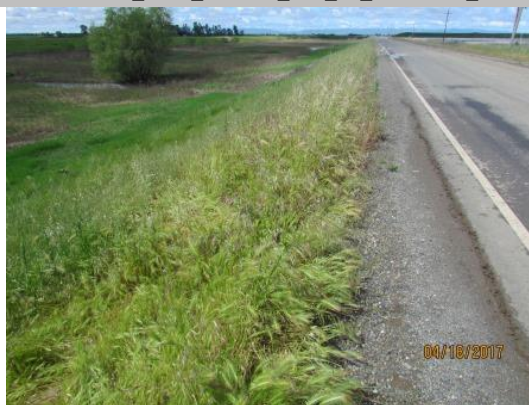
Photo 1 of 1 : SP_2017_ST0012_295_20_20170419_00019.jpg

Tall grass on waterside levee slope, blocking visibility. Spring 2017.

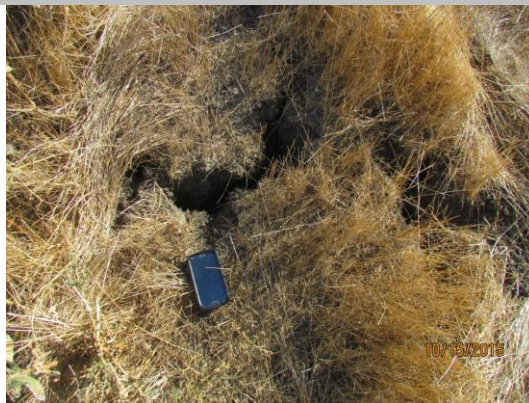
Photo 1 of 3 : SP_2017_ST0012_295_16_20170320_00014.jpg

LM Start	0.90	Rating **	A/W	Issue No.	16
LM End	0.90	Issue Type +	Ma	Location *	LS
Category	Earthen Levee			GPS Latitude/Longitude	
				Start	End
Item	Cracking			38.590456 °	38.590456 °
				-121.681952 °	-121.681952 °
DWR ID	DWR_ST0012_01_f_ 2015_16				
Comment Code					
CR1 : Monitor and have inspected by geotechnical engineer.					
Inspector Comment

View of the dessication cracking on the landward side of the levee. Fall 2015.

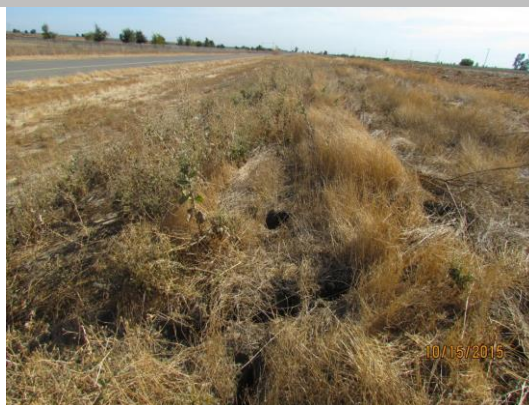
Photo 2 of 3 : SP_2017_ST0012_295_16_20170320_00015.jpg

Perspective view of the crack looking downstream. Fall 2015.

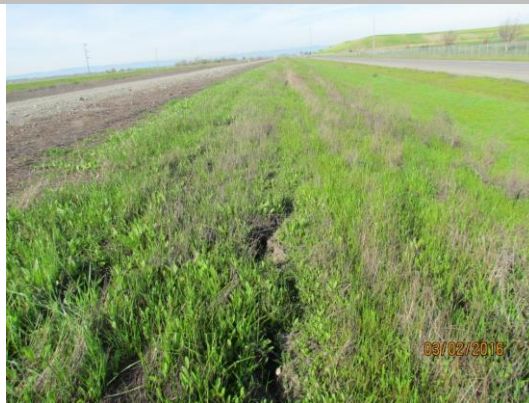
Photo 3 of 3 : SP_2017_ST0012_295_16_20170320_00016.jpg

View of the crack on the landward side of the levee looking upstream. Spring 2016.

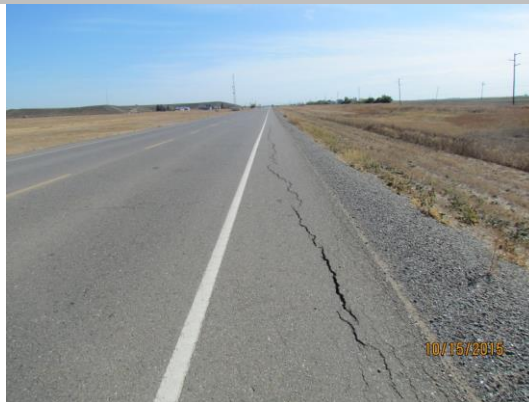
Photo 1 of 3 : SP_2017_ST0012_295_15_20170320_00011.jpg

LM Start	1.86	Rating **	A/W	Issue No.	15
LM End	1.88	Issue Type +	Ma	Location *	CR
Category	Earthen Levee			GPS Latitude/Longitude	
				Start	End
Item	Cracking			38.590378 °	38.590379 °
				-121.699630 °	-121.699920 °
DWR ID	DWR_ST0012_01_f_2015_15				
Comment Code					
CR1 : Monitor and have inspected by geotechnical engineer.					
Inspector Comment					
Cracks starting to form on the waterward slope.

Perspective view of the crack on the crown of the levee looking downstream. Fall 2015.

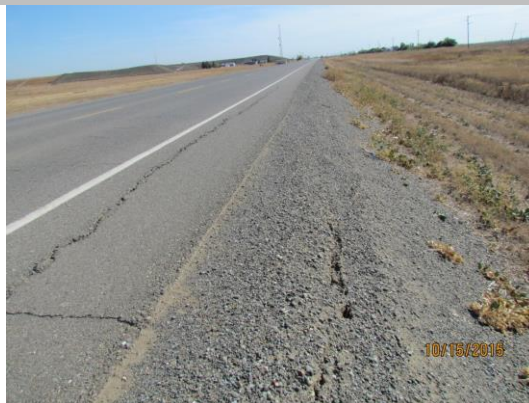
Photo 2 of 3 : SP_2017_ST0012_295_15_20170320_00012.jpg

Cracks are starting to form on the waterward slope of the levee looking downstream. Fall 2015.

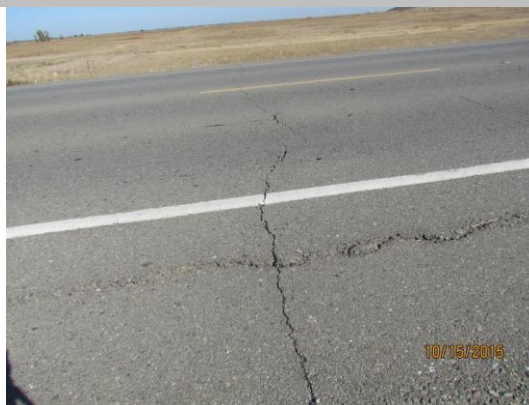
Photo 3 of 3 : SP_2017_ST0012_295_15_20170320_00013.jpg

There is another crack perpendicular to the crack on the levee crown. Fall 2015.

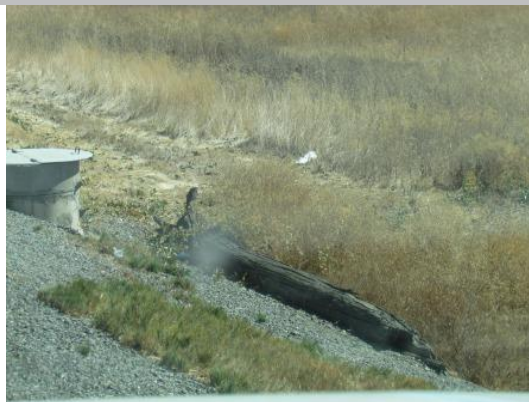
Photo 1 of 1 : SP_2017_ST0012_295_5_20170320_00003.jpg

LM Start	2.02	Rating **	M	Issue No.	5
LM End	2.02	Issue Type +	En	Location *	WS
Category	Earthen Levee			GPS Latitude/Longitude	
				Start	End
Item	Encroachments			38.590381 °	38.590381 °
				-121.702554 °	-121.702554 °
DWR ID	DWR_ST0012_01_f_ 2016_5				
Comment Code					
DE : Debris					
Inspector Comment

Downed tree on waterside slope looking downstream. Fall 2016.

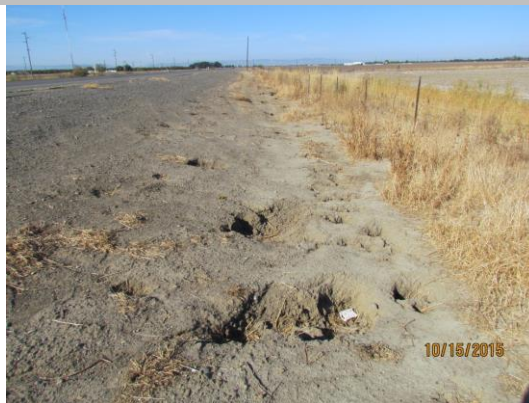
Photo 1 of 1 : SP_2017_ST0012_295_10_20170320_00005.jpg

LM Start	2.93	Rating **	M	Issue No.	10
LM End	3.00	Issue Type +	Ma	Location *	LS
Category	Earthen Levee			GPS Latitude/Longitude	
				Start	End
Item	Erosion / Bank Caving			38.590572 °	38.590653 °
				-121.719349 °	-121.720714 °
DWR ID	DWR_ST0012_01_s_2015_10				
Comment Code					
E2 : Schedule repair of erosion site prior to the next inspection.					
Inspector Comment					
Area is known to erode and may be because of the material of the levee.

View of the erosion on the landward side of the levee looking upstream. Fall 2015.

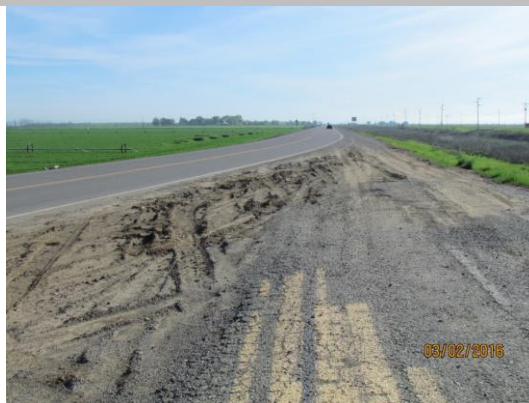
Photo 1 of 1 : SP_2017_ST0012_295_13_20170320_00009.jpg

LM Start	3.36	Rating **	M	Issue No.	13
LM End	3.36	Issue Type +	Ma	Location *	LS
Category	Earthen Levee			GPS Latitude/Longitude	
				Start	End
Item	Crown Surface / Depressions / Rutting			38.590620 °	38.590620 °
				-121.727385 °	-121.727385 °
DWR ID	DWR_ST0012_01_s_2016_13				
Comment Code					
C2 : Repair depressions or ruts in the crown or slope.					
Inspector Comment

View of the ruts created by vehicles on the crown of the levee looking downstream. Spring 2016.

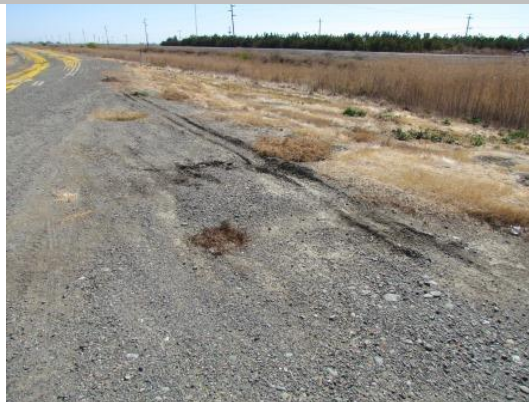
Photo 1 of 1 : SP_2017_ST0012_295_3_20170320_00001.jpg

LM Start	3.50	Rating **	M	Issue No.	3
LM End	3.50	Issue Type +	Ma	Location *	CR
Category	Earthen Levee			GPS Latitude/Longitude	
				Start	End
Item	Crown Surface / Depressions / Rutting			38.590731 °	38.590731 °
				-121.729906 °	-121.729906 °
DWR ID	DWR_ST0012_01_f_2016_3				
Comment Code					
C2 : Repair depressions or ruts in the crown or slope.					
Inspector Comment

Ruts on levee crown due to vehicular activity. Fall 2016.

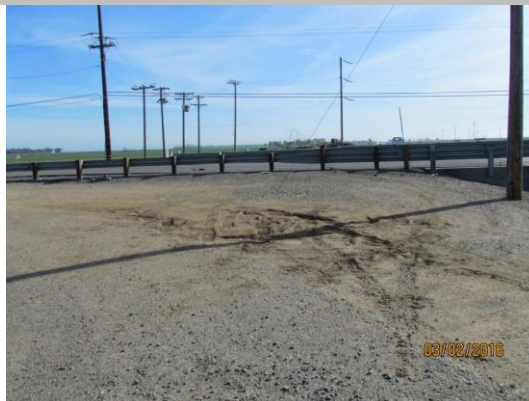
Photo 1 of 1 : SP_2017_ST0012_295_18_20170320_00017.jpg

LM Start	3.54	Rating **	M	Issue No.	18
LM End	3.54	Issue Type +	Ma	Location *	CR
Category	Earthen Levee			GPS Latitude/Longitude	
				Start	End
Item	Crown Surface / Depressions / Rutting			38.590685 °	38.590685 °
				-121.730657 °	-121.730657 °
DWR ID	DWR_ST0012_01_s_2016_18				
Comment Code					
C2 : Repair depressions or ruts in the crown or slope.					
Inspector Comment

View of the ruts caused by vehicles on the crown of the levee looking downstream. Spring 2016.

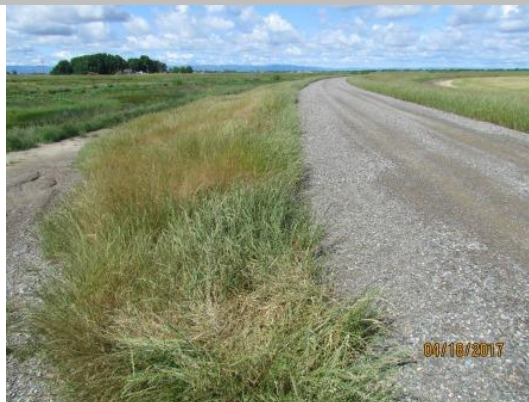
Photo 1 of 1 : SP_2017_ST0012_295_21_20170419_00020.jpg

LM Start	3.55	Rating **	U	Issue No.	21
LM End	5.04	Issue Type +	Ma	Location *	WS
Category	Earthen Levee			GPS Latitude/Longitude	
				Start	End
Item	Vegetation			38.590704 °	38.599981 °
				-121.730787 °	-121.753014 °
DWR ID	DWR_ST0012_01_s_2017_21				
Comment Code					
V1 : Control annual grass and weeds on the levee slopes and easements.					
Inspector Comment

Tall grass on waterside levee slope, blocking visibility. Spring 2017.

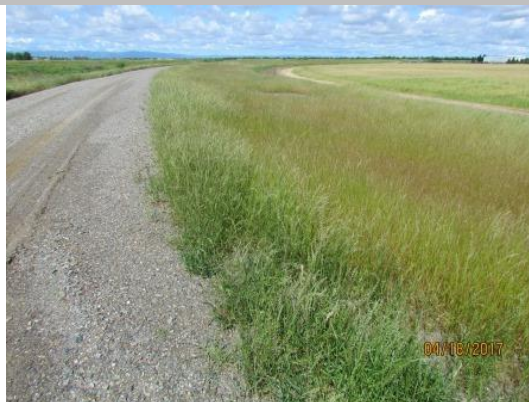
Photo 1 of 1 : SP_2017_ST0012_295_22_20170419_00021.jpg

LM Start	3.55	Rating **	U	Issue No.	22
LM End	5.04	Issue Type +	Ma	Location *	LS
Category	Earthen Levee			GPS Latitude/Longitude	
				Start	End
Item	Vegetation			38.590704 °	38.599981 °
				-121.730787 °	-121.753014 °
DWR ID	DWR_ST0012_01_s_2017_22				
Comment Code					
V1 : Control annual grass and weeds on the levee slopes and easements.					
Inspector Comment

Tall grass on landside levee slope, blocking visibility. Spring 2017.

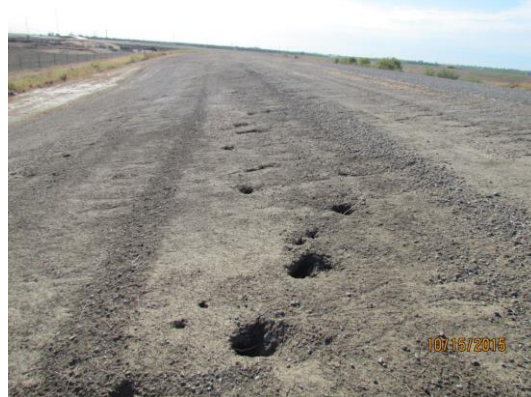
Photo 1 of 2 : SP_2017_ST0012_295_12_20170320_00007.jpg

LM Start	3.90	Rating **	A/W	Issue No.	12
LM End	3.90	Issue Type +	Ma	Location *	LS
Category	Earthen Levee			GPS Latitude/Longitude	
				Start	End
Item	Cracking			38.594149 °	38.594149 °
				-121.735254 °	-121.735254 °
DWR ID	DWR_ST0012_01_f_2015_12				
Comment Code					
CR1 : Monitor and have inspected by geotechnical engineer.					
Inspector Comment					
The sinkholes are caused by the material of the levee and runoffs. These are not rodent holes.

View of the sinkholes on the landward side of the levee looking downstream. Fall 2015.

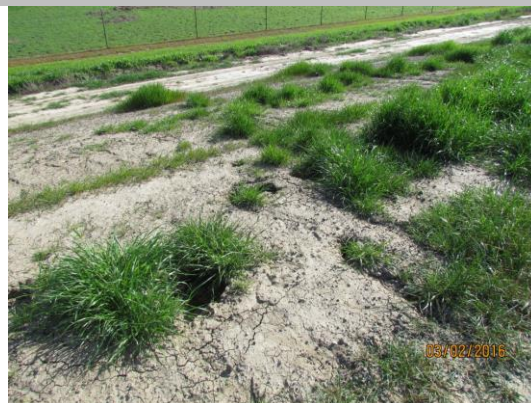
Photo 2 of 2 : SP_2017_ST0012_295_12_20170320_00008.jpg

View of the sinkholes on the landward side of the levee. Sinkholes are caused due to material of the levee and runoffs. Spring 2016.

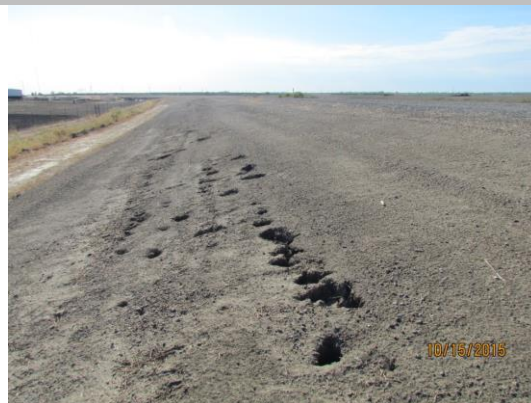
Photo 1 of 1 : SP_2017_ST0012_295_11_20170320_00006.jpg

LM Start	3.94	Rating **	A/W	Issue No.	11
LM End	3.94	Issue Type +	Ma	Location *	LS
Category	Earthen Levee			GPS Latitude/Longitude	
				Start	End
Item	Cracking			38.594645 °	38.594645 °
				-121.735712 °	-121.735712 °
DWR ID	DWR_ST0012_01_f_2015_11				
Comment Code					
CR1 : Monitor and have inspected by geotechnical engineer.					
Inspector Comment					
The sinkholes are caused by the material of the levee and runoffs. These are not rodent holes.

View of the sinkholes on the landward side of the levee looking downstream. Fall 2015.

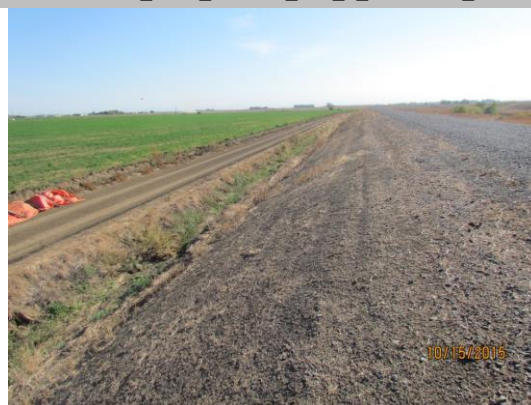
Photo 1 of 1 : SP_2017_ST0012_295_4_20170320_00002.jpg

LM Start	4.12	Rating **	M	Issue No.	4
LM End	4.60	Issue Type +	En	Location *	LS
Category	Earthen Levee			GPS Latitude/Longitude	
				Start	End
Item	Encroachments			38.596784 °	38.599845 °
				-121.737662 °	-121.744830 °
DWR ID	DWR_ST0012_01_s_2012_4				
Comment Code					
DT : Ditch					
Inspector Comment					
Ditch is at the levee toe.

View of the ditch on the landward side of the levee looking downstream. Fall 2015.

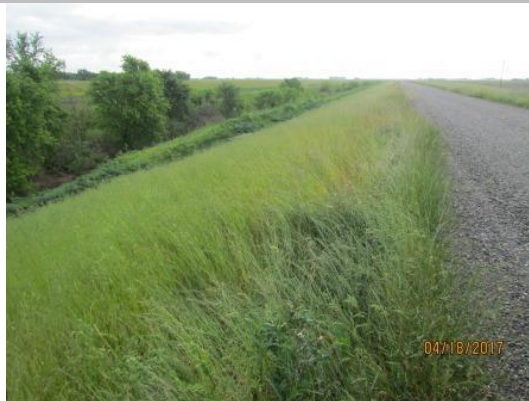
Photo 1 of 1 : SP_2017_ST0012_296_12_20170419_00037.jpg

Tall grass on waterside levee slope, blocking visibility. Spring 2017.

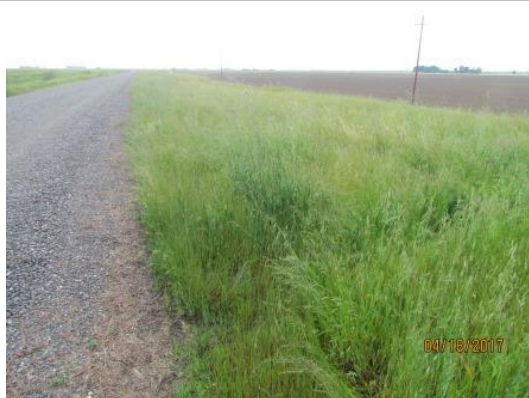
Photo 1 of 1 : SP_2017_ST0012_296_6_20170419_00038.jpg

Tall grass on landside levee slope, blocking visibility. Spring 2017.

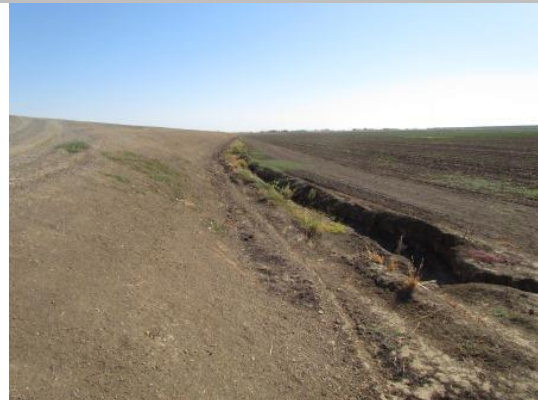
Photo 1 of 2 : SP_2017_ST0012_296_7_20170320_00005.jpg

An updated view of the ditch near LM 0.29. Fall 2016.

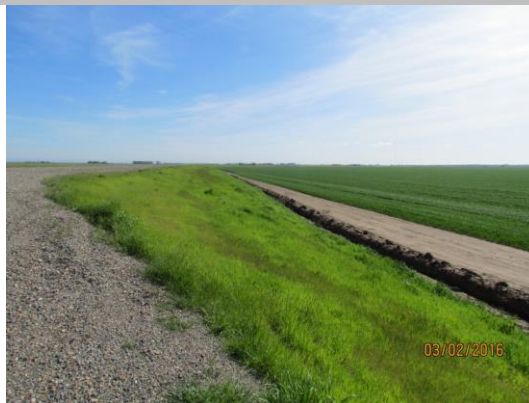
Photo 2 of 2 : SP_2017_ST0012_296_7_20170320_00006.jpg

View of the ditch on the landward side of the levee looking downstream. Spring 2016.

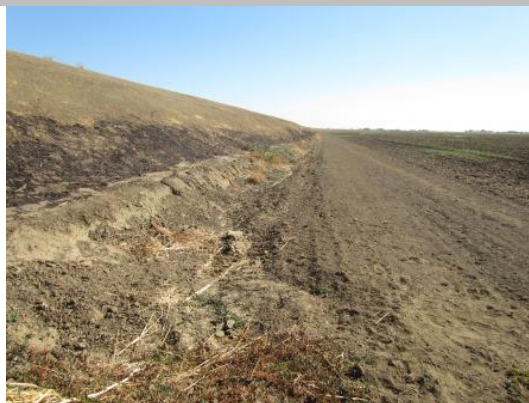
Photo 1 of 1 : SP_2017_ST0012_296_26_20170320_00033.jpg

View of a tilling issue at LS levee toe near LM 0.40 where ditch ends. Fall 2016.

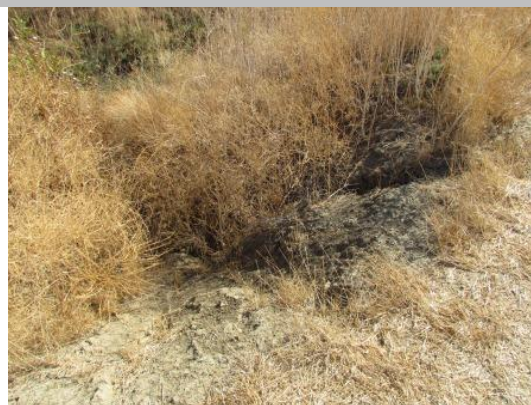
Photo 1 of 1 : SP_2017_ST0012_296_23_20170320_00029.jpg

View of an erosion site around UCIP pipe FSID 13725 on waterward side of the levee. Fall 2016.

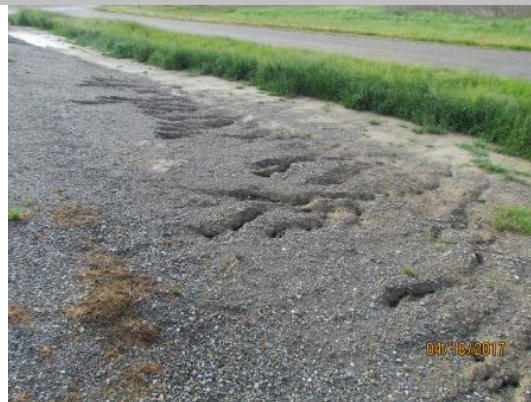
Photo 1 of 1 : SP_2017_ST0012_296_21_20170419_00039.jpg

LM Start	1.54	Rating **	M	Issue No.	21
LM End	1.54	Issue Type +	Ma	Location *	LS
Category	Earthen Levee			GPS Latitude/Longitude	
				Start	End
Item	Erosion / Bank Caving			38.590108 °	38.590108 °
				-121.731254 °	-121.731254 °
DWR ID	DWR_ST0012_02_s_2017_21				
Comment Code					
E2 : Schedule repair of erosion site prior to the next inspection.					
Inspector Comment					
Rills on landside levee slope.

View of rills on landside levee slope. Spring 2017.

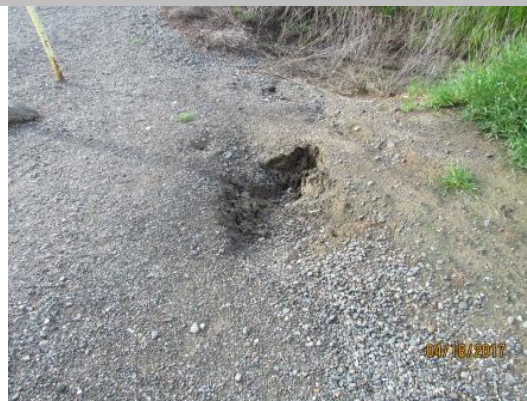
Photo 1 of 1 : SP_2017_ST0012_296_29_20170419_00040.jpg

LM Start	1.57	Rating **	M	Issue No.	29	
LM End	1.57	Issue Type +	Ma	Location *	LS	
Category	Earthen Levee			GPS Latitude/Longitude		
				Start		End
Item	Slope Stability			38.590064 °		38.590064 °
				-121.730723 °		-121.730723 °
DWR ID	DWR_ST0012_02_s_2017_29					
Comment Code						
S3 : Repair the levee slope damaged by vehicle traffic and prevent access where possible.						
Inspector Comment						
Tire damage on landside levee slope.

View of tire damage on landside levee slope. Spring 2017.

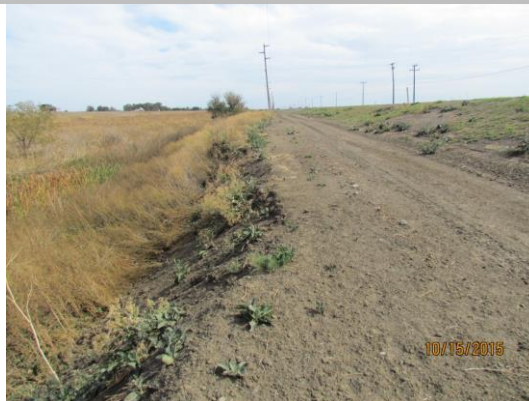
Photo 1 of 2 : SP_2017_ST0012_296_5_20170320_00003.jpg

View of the erosion on the edge of the channel on the waterward side of the levee looking downstream. Fall 2015.

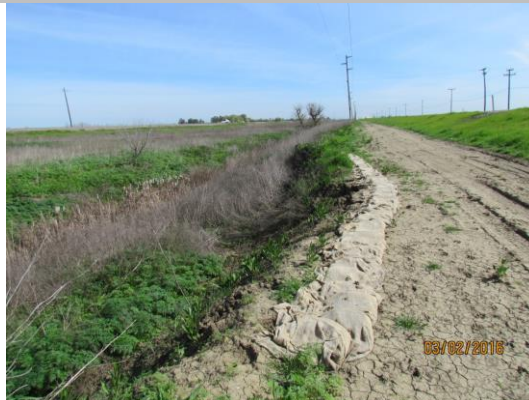
Photo 2 of 2 : SP_2017_ST0012_296_5_20170320_00004.jpg

View of the erosion on the edge of the channel on the waterward side of the levee looking downstream. Spring 2016.

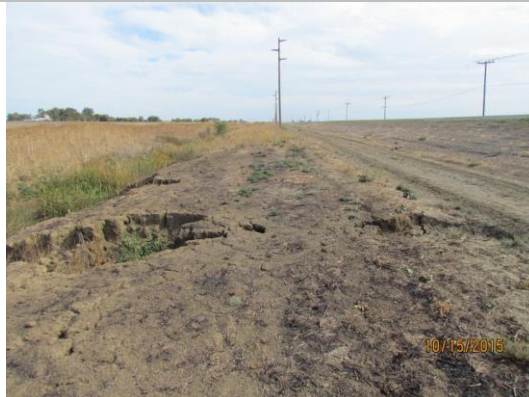
Photo 1 of 2 : SP_2017_ST0012_296_19_20170320_00023.jpg

View of the erosion at the edge of the channel on the waterward side of the levee looking downstream. Fall 2015.

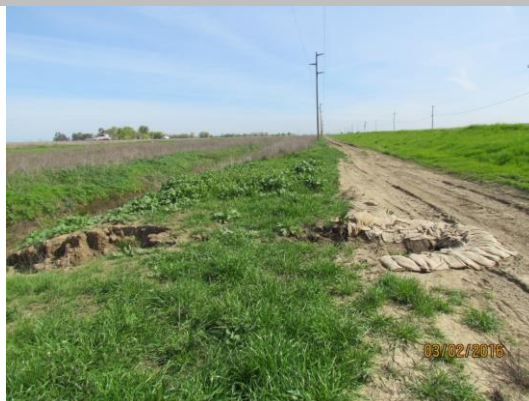
Photo 2 of 2 : SP_2017_ST0012_296_19_20170320_00024.jpg

View of the erosion at the edge of the channel on the waterward side of the levee looking downstream. Spring 2016.

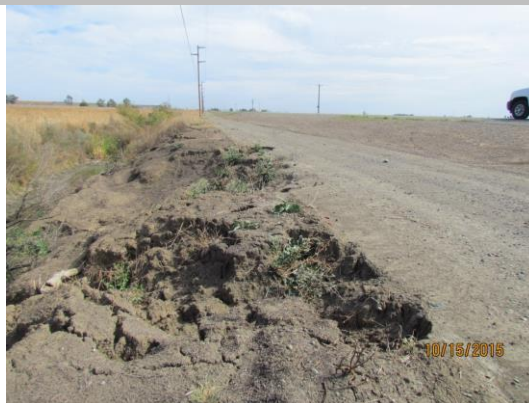
Photo 1 of 1 : SP_2017_ST0012_296_20_20170320_00025.jpg

View of the erosion at the edge of the channel looking downstream. Fall 2015.

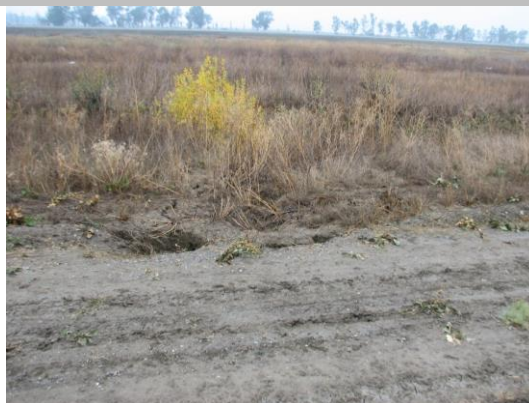
Photo 1 of 2 : SP_2017_ST0012_296_10_20170320_00011.jpg

Erosion on toe road. Fall 2014.

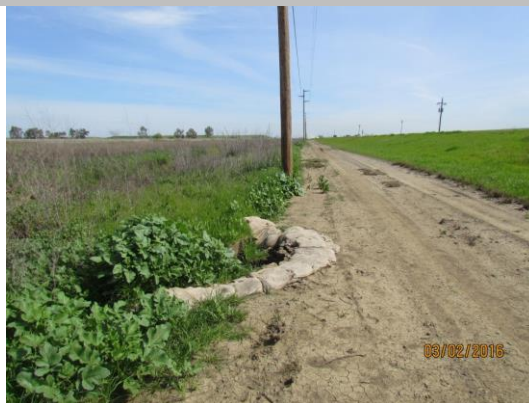
Photo 2 of 2 : SP_2017_ST0012_296_10_20170320_00012.jpg

View of the erosion on the toe road looking downstream. Spring 2016.

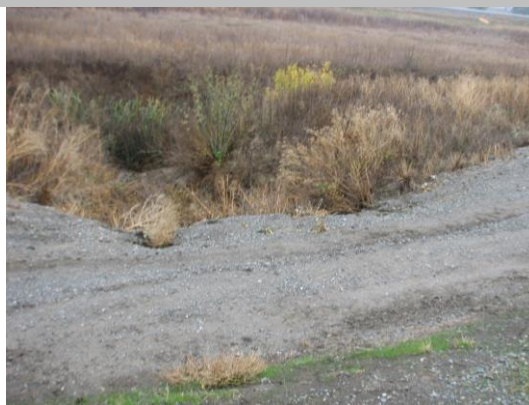
Photo 2 of 3 : SP_2017_ST0012_296_9_20170320_00009.jpg

Erosion on toe road. Fall 2014.

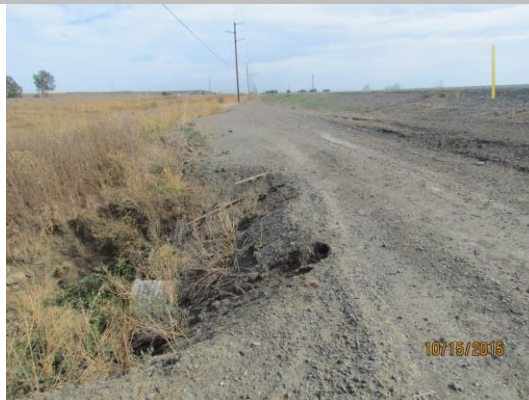
Photo 3 of 3 : SP_2017_ST0012_296_9_20170320_00010.jpg

View of the erosion on the waterward side of the levee looking downstream. Fall 2015.

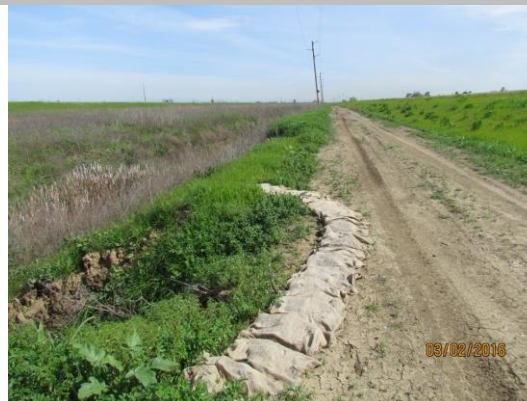
Photo 1 of 1 : SP_2017_ST0012_296_18_20170320_00022.jpg

View of the erosion on the waterward side looking downstream. Spring 2016.

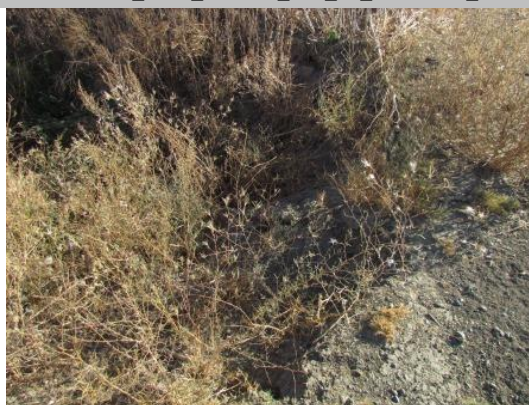
Photo 1 of 3 : SP_2017_ST0012_296_11_20170320_00013.jpg

An updated view of the erosion site that keeps on growing toward WS levee slope. Fall 2016.

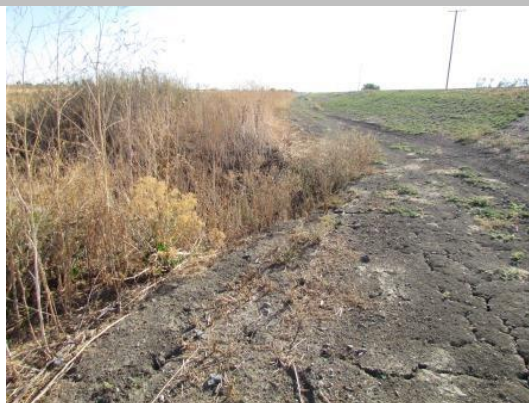
Photo 2 of 3 : SP_2017_ST0012_296_11_20170320_00014.jpg

Perspective view of the site. Fall 2016.

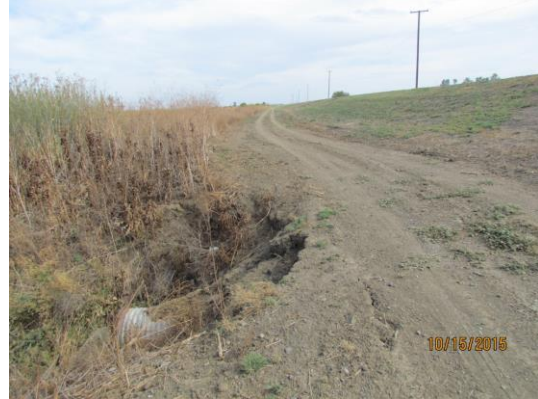
Photo 3 of 3 : SP_2017_ST0012_296_11_20170320_00015.jpg

View of the erosion at the edge of the channel on the waterward side of the levee looking downstream. Fall 2015.

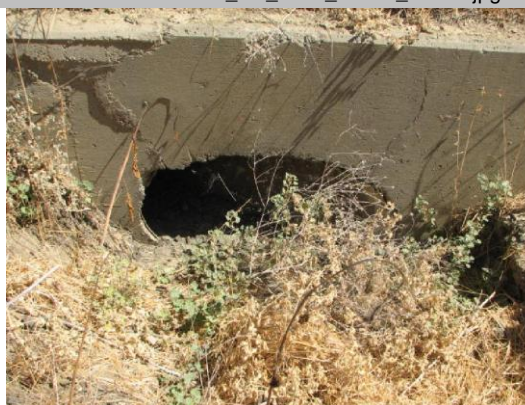
Photo 3 of 3 : UCIP_SP_2017_45285_22810.jpg

Landside view- soil and debris on mouth of the inlet pipe.

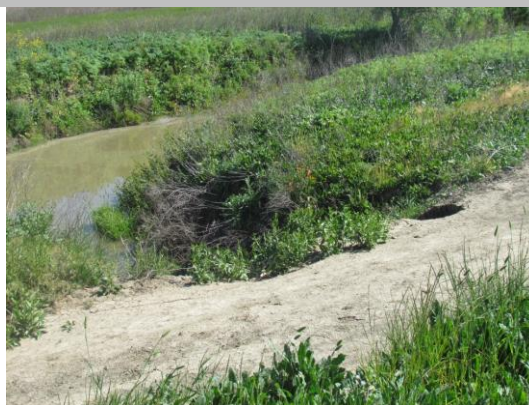
Photo 2 of 3 : SP_2017_ST0012_296_15_20170320_00018.jpg

View of the erosion on the edge of the channel on the waterward side of the levee. Spring 2015.

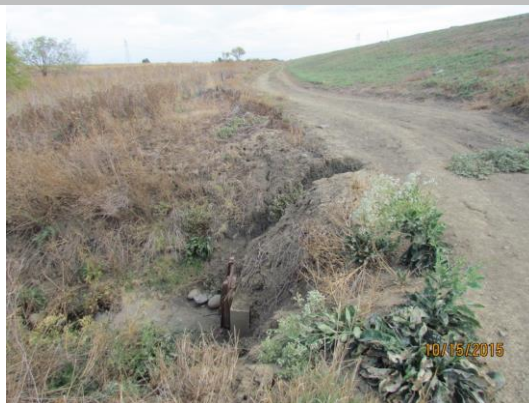
Photo 3 of 3 : SP_2017_ST0012_296_15_20170320_00019.jpg

View of the erosion at the edge of the channel on the waterward side of the levee looking downstream. Fall 2015.

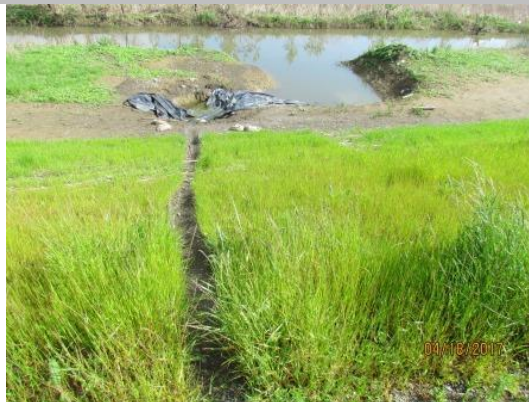
Photo 1 of 1 : SP_2017_ST0012_296_32_20170419_00041.jpg

View of erosion on waterside levee slope. Spring 2017.

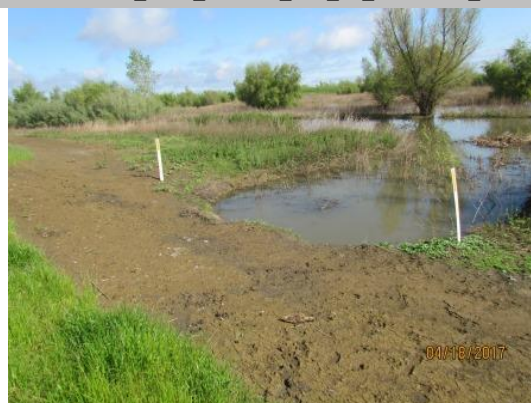
Photo 1 of 1 : SP_2017_ST0012_296_33_20170419_00042.jpg

View of erosion into waterside levee prism. Spring 2017.

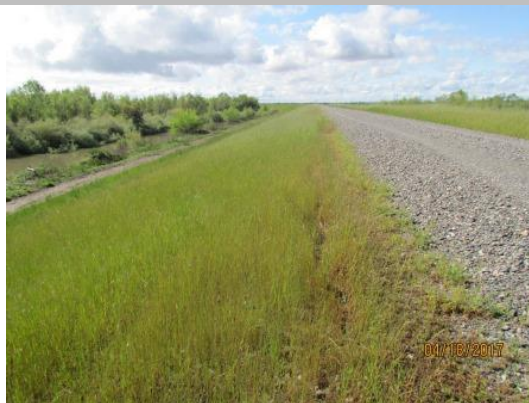
Photo 1 of 1 : SP_2017_ST0012_296_34_20170419_00043.jpg

Tall vegetation on waterside levee slope, blocking visibility. Spring 2017.

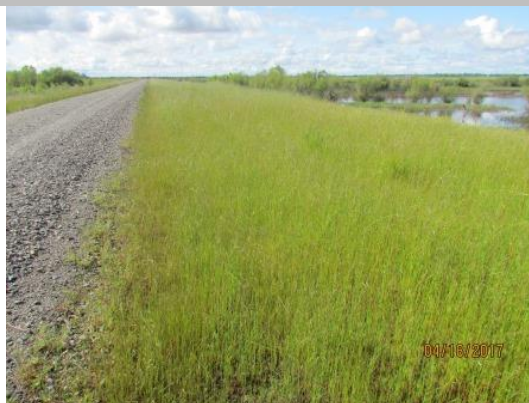
Photo 1 of 1 : SP_2017_ST0012_296_35_20170419_00044.jpg

Tall grass on landside levee slope, blocking visibility. Spring 2017.

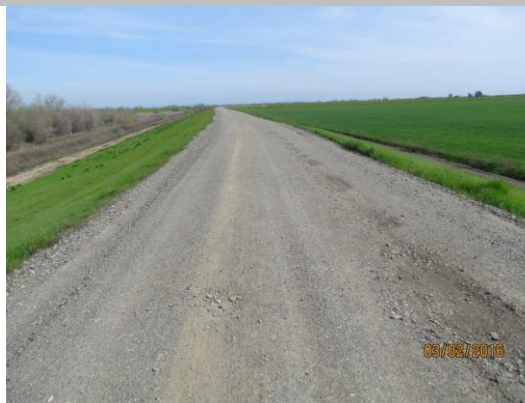
Photo 1 of 1 : SP_2017_ST0012_296_25_20170320_00032.jpg

View of the crown of the levee looking downstream. Road needs to be regraded. Spring 2016.
